Kintyre to Ardnamurchan (2007)

Replacement plans for Sailing Directions

Plan Ref. No. **Kintyre to Ardnamurchan (2007)**
P/323 Page 55 Cullipool Issue Date: May 07

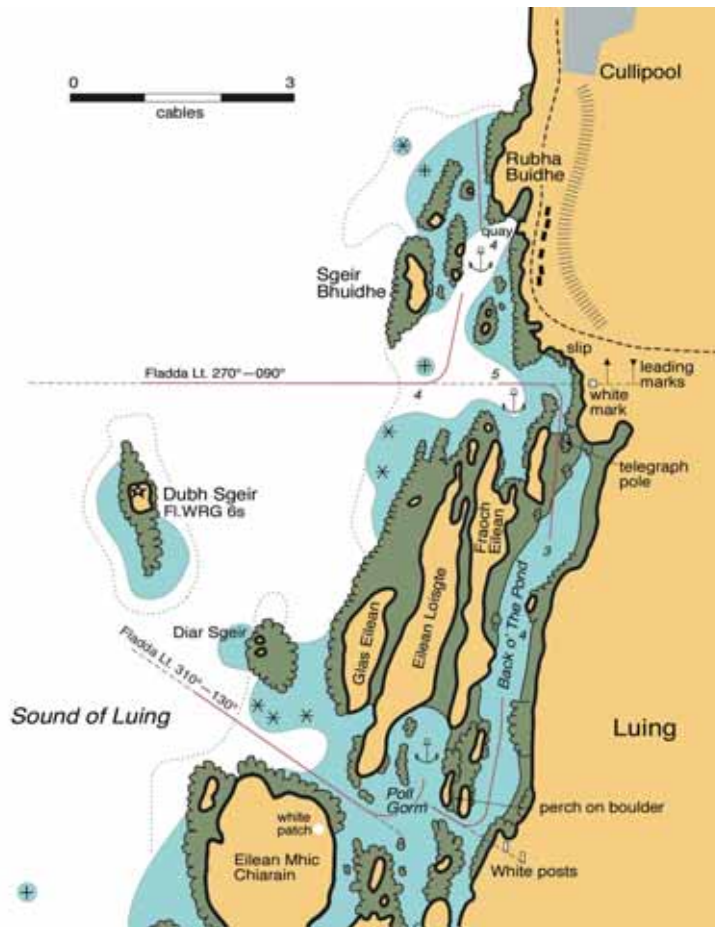
On the plan on p. 55 **insert** two additional drying and awash rock symbols approximately 1.5c and 1c respectively to the W of Rubha Buidhe as shown on the replacement plan attached.
