Ardnamurchan to Cape Wrath (2017)

This PDF file contains all the amendments for the above volume of the CCC Sailing Directions issued since the edition date shown in brackets. They are grouped by the date of issue and listed by page number. Plans are included only where major changes have been made or when certain amendments are difficult to describe.

Amendments added Apr 2020

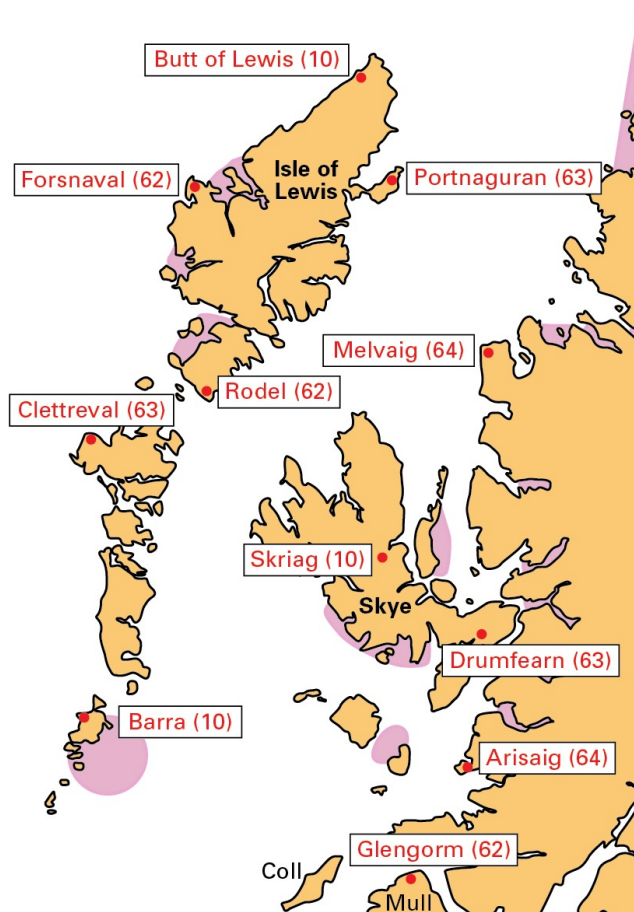
Amendment No.1023 published in April 2018 is cancelled and the following amendments to the original 2017 printed edition should be made:

p.7; LH col; *Coastguard channels*; para. 7; Line 3; **Delete** 'Ch. 23, 84, 86' and **substitute** Ch 62, 63, 64'

p.7; RH col; para 1; Line 5; Delete '23' and substitute '63'

p.7; RH col; para 1; Line 6; Delete '84' and substitute '62'

p.7; RH col; para 1; Line 7; Delete '86' and substitute '64'

p.13; Plan; **Substitute** plan below.

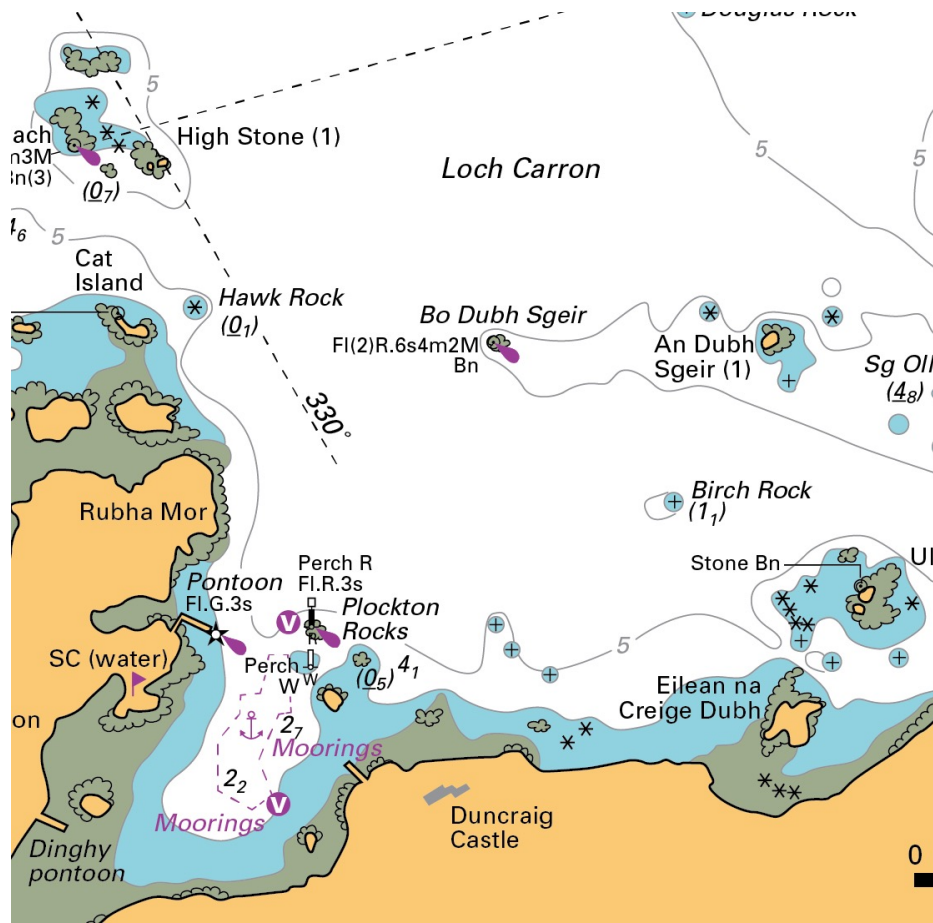
Two rocks with less than 2m over them have been reported lying to the east of Plockton Rocks.

p.90; Plan; **Amend** as plan below:
